INDOOR AIR QUALITY ASSESSMENT

**New Central Elementary School
38 Pomeworth Street
Stoneham, Massachusetts**

Prepared by:
Massachusetts Department of Public Health
Bureau of Environmental Health Assessment
Emergency Response/Indoor Air Quality Program
March 2003

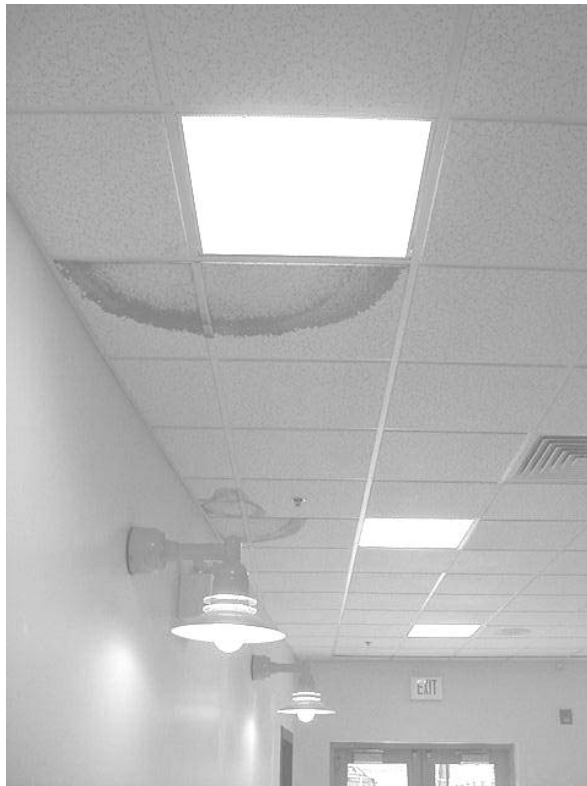
Picture 1

A few areas had water-stained ceiling tiles, which are evidence of roof or plumbing leaks (see Picture 1). Water-damaged ceiling tiles can provide a source of microbial growth and should be replaced after a water leak is discovered.

Water Damaged Ceiling Tiles in Hallway

5. Repair any existing water leaks and replace any remaining water-stained ceiling tiles. Examine the areas above these tiles for microbial growth. Disinfect areas of water leaks with an appropriate antimicrobial as needed.

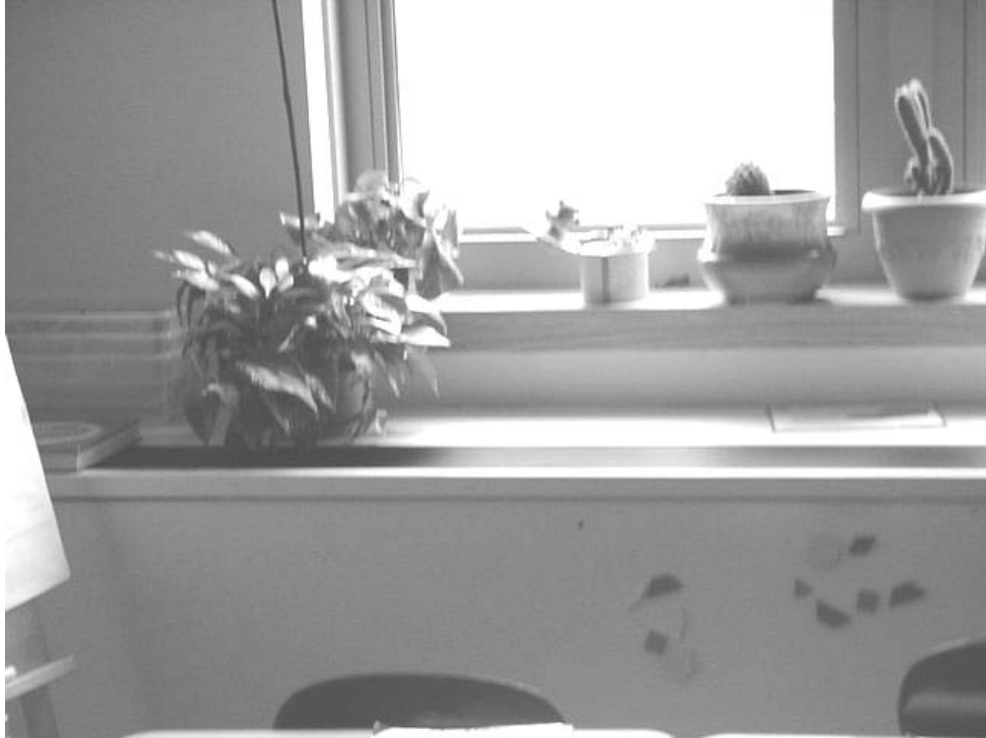
Picture 2

Several classrooms had a number of plants, some of which were located on top of univent air diffusers (see Picture 2). Moistened plant soil and drip pans can serve as a source of mold growth. Over-watering of plants should be avoided and staff should ensure that plants are located away from univents to prevent the aerosolization of dirt, pollen or mold.

Plants on/near Univent Air Diffuser

6. Ensure plants are located away from univents in classrooms. Ensure drip pans are placed underneath plants in classrooms. Examine drip pans periodically for microbial growth and disinfect with an appropriate antimicrobial where necessary.

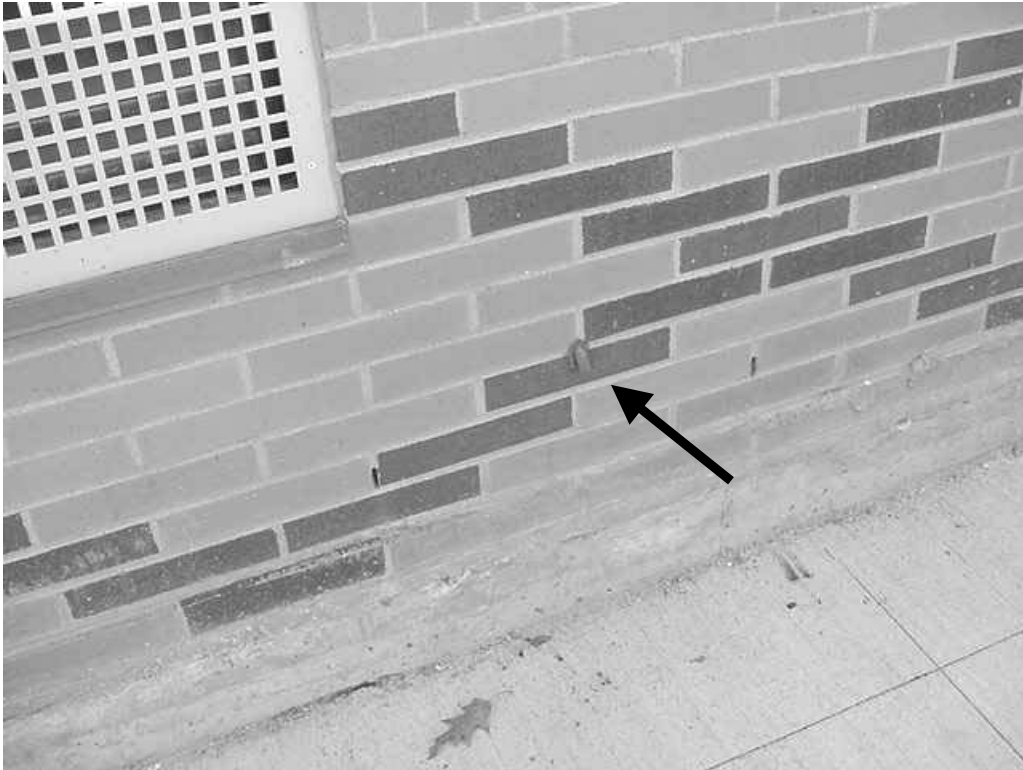
Picture 3

Condensation drains (see Picture 3) from several univents were noted to exit the rear of the building at a height of over six feet. Drain water from this system tends to splatter, which wets the exterior brick. Repeated contact with water may result in water accumulation against the exterior wall, which can break down mortar around brick. Over time, freezing and thawing can create cracks and fissures in brickwork, ultimately compromising the integrity of the building envelope and providing a means of water entry into the building.

Univent Condensation Drain

10. Store cleaning products properly and out of reach of students.
11. Install flashing or a gutter system to dripping univent drain pipe(s) to carry water away from the building and prevent water pooling.

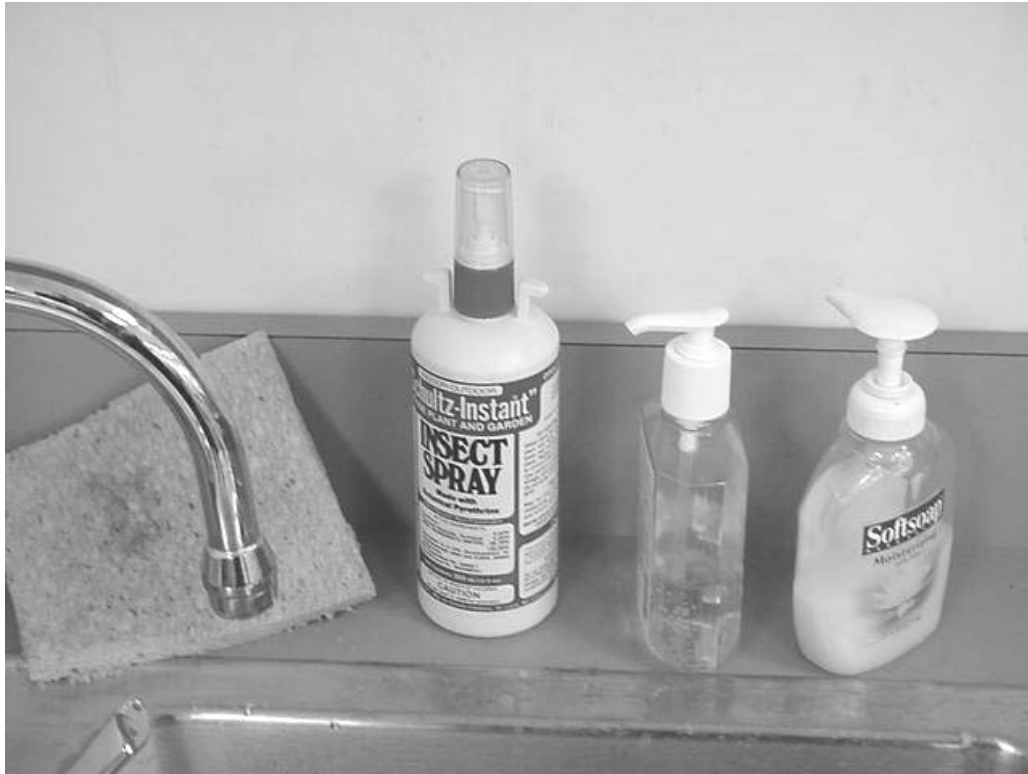
Picture 4

A spray bottle of pesticide was observed in classroom 106 (see Picture 4). Only individuals with a pesticide applicator license can apply this product in a public school. Insecticides contain chemicals that can be irritating to the eyes, nose and throat. Under current

Spray Bottle of Pesticide on Classroom Sink

9. Remove the pesticide container from classroom 106. It is highly recommended that the principles of integrated pest management (IPM) be used to rid this building of pests.

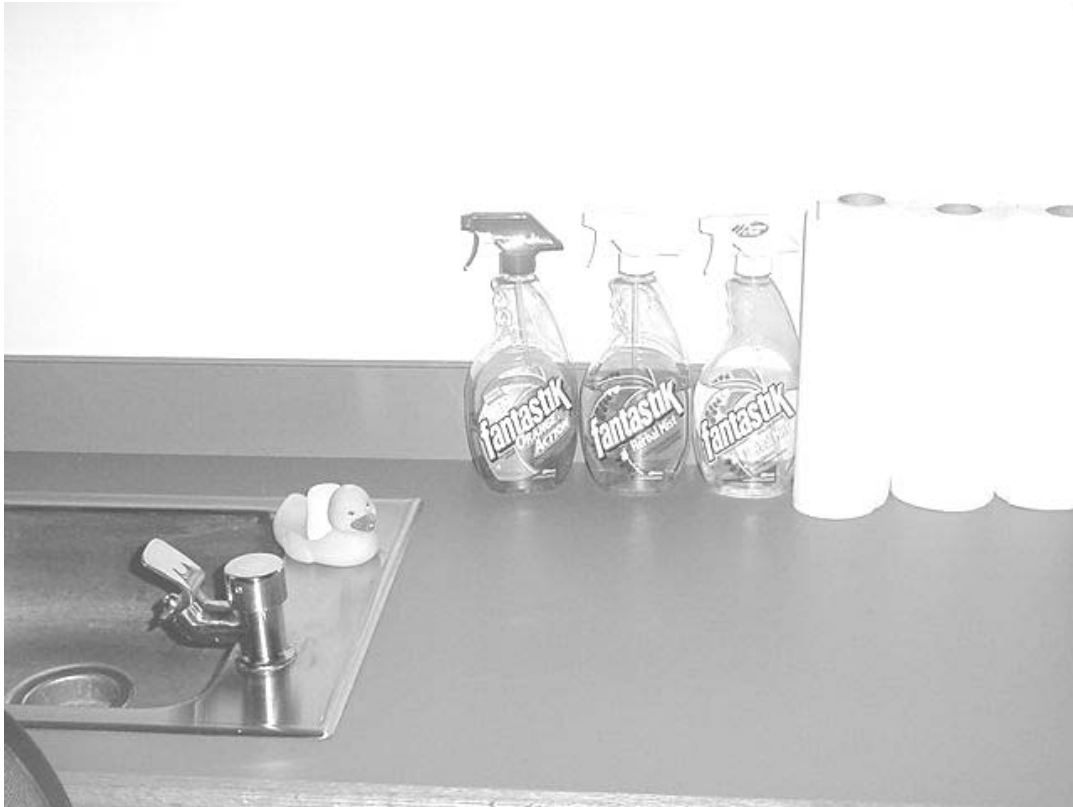
Picture 5

Cleaning products were found on counter tops in classrooms (see Picture 5). Cleaning products contain chemicals (such as bleach or ammonia-related compounds), which can be irritating to the eyes, nose and throat. These items should be stored properly and out of the reach of students.

Spray Cleaning Products on Classroom Sink
